<b>Overview</b>	
<b>Case Study #</b>	002
<b>Date</b>	27 July 2025
<b>Location</b>	Isles of Scilly
<b>Type of Boat</b>	12m yacht
<b>Sailing or Motoring</b>	Motor
<b>Incident Summary</b>	Fishing line around propellor
<b>Damage Caused</b>	N/A
<b>Rescue or Solution</b>	Able to motor to harbour

## Lobster Pot Entanglement - Case Study Case Study # 002

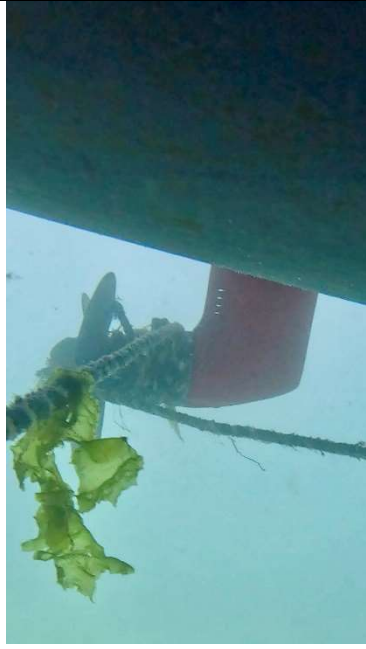
<b>Description of Incident</b>
<p>Vessel (12m yacht) had lowered sails and was motoring towards the entrance to New Grimsby sound when the engine stalled. Engine restarted but stalled again.</p> <p>Believed to be something round the prop. No lines visible. Sails up to stem the tide (1.5 knots, Springs) as we were being set down to rocks.</p> <p>Engine started on third attempt. Motored to mooring. No sign of lines until slack water when the offending line (attached to saildrive) floated to the surface as bundle of rope.</p> <p>Line cut free by crew diving under the hull.</p>

<p>File name: Case Study 002 - image 1          Location: Isles of Scilly          Photo Description: Fishing line around propellor          Photo Credit: © Tim Crump</p>

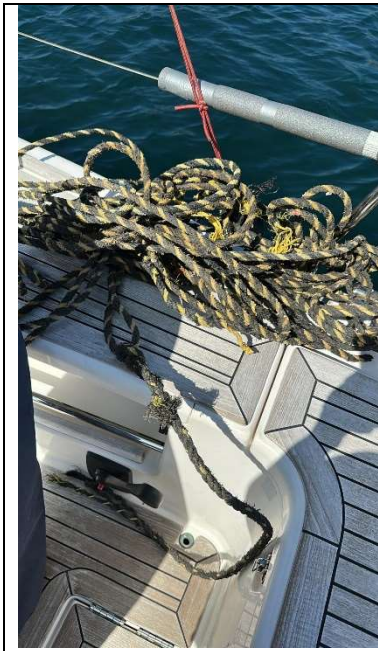
File name: Case Study 002 - image 2  
Location: Isles of Scilly  
Photo Description: Removed fishing line  
Photo Credit: © Tim Crump
