Failure of a throw bag rescue line during a boat capsize rescue drill

24 March 2018

MAIB SAFETY BULLETIN 2/2018

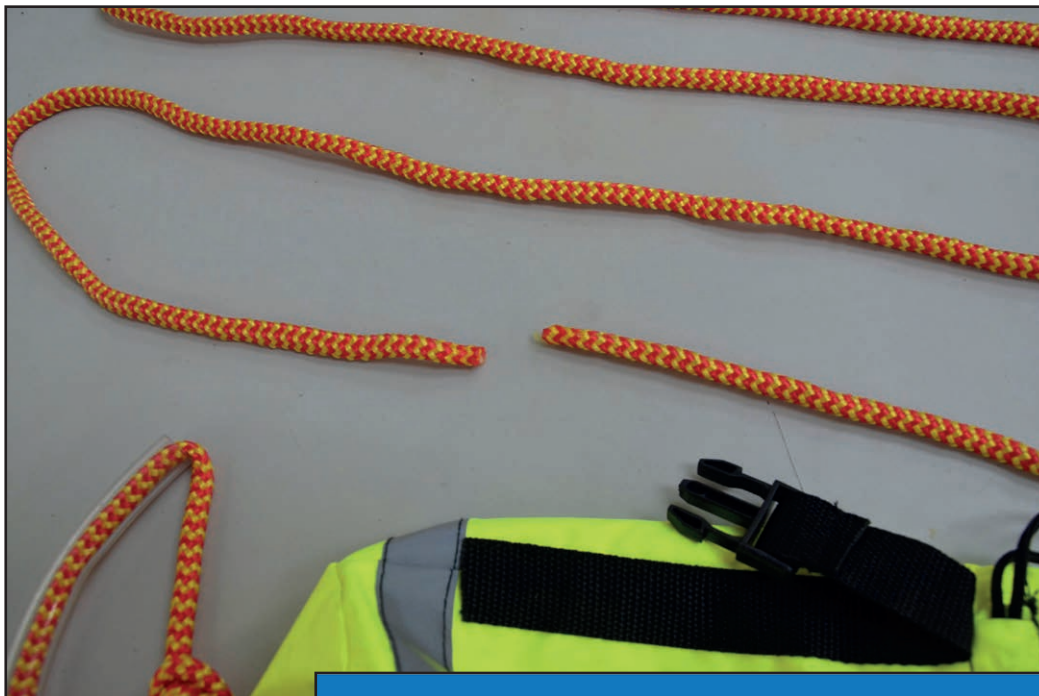
Figure 1: RIBER 15m throw bag rescue line

A defective throw bag rescue line was discovered while Warrington Rowing Club was conducting boat capsizing drills for new rowers at Halton Baths in Cheshire, UK. A 15m long polypropylene rescue line in a throw bag, supplied by Riber Products Limited (RIBER), parted (**Figure 1**) while a young person in the water was being pulled to the side of the pool during a simulated rescue. There were no injuries. The rowing club safety advisor subsequently found another throw bag with a defective rescue line that had been purchased from the same supplier. RIBER was informed and the company contacted its customers after identifying a batch of 208 throw bags that could be at risk. A further three defective rescue lines have been identified as a consequence of the customer warning notice posted on Facebook (**Figure 2**).
