SB1/2018

## Use of safety harness tethers on sailing yachts

### Fatal accident on board the sailing yacht

## MAIB SAFETY BULLETIN 1/2018

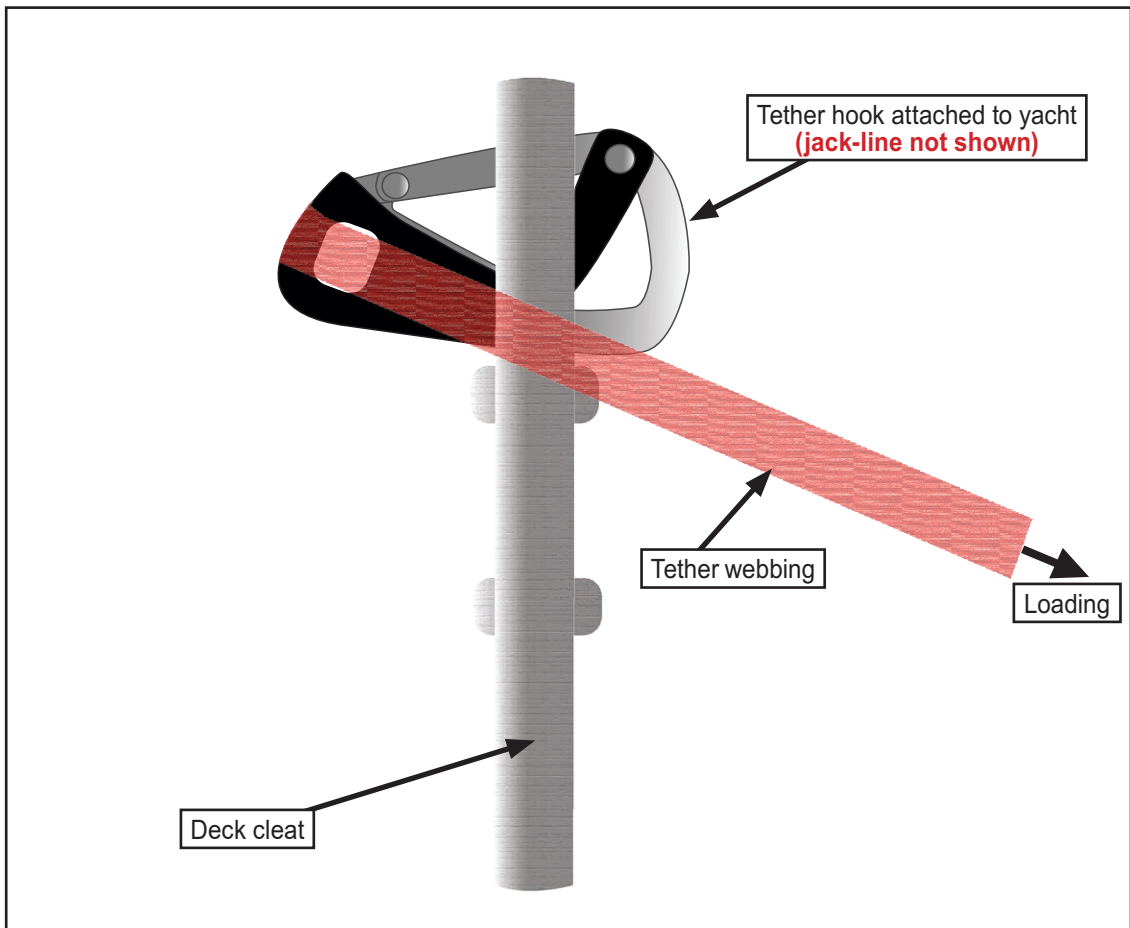
A safety issue identified during the investigation was that the hook on the end of Mr Speirs' tether had become caught under a deck cleat (see **Figure 1**), resulting in a lateral loading that was sufficient to cause the hook to distort (see **Figure 2**) and eventually release.

**Figure 1:** Tether hook under deck cleat

To prevent the strength of a safety harness tether becoming compromised in-service due to lateral loading on the tether hook, the method used to anchor the end of the tether to the vessel should be arranged to ensure that the tether hook cannot become entangled with deck fittings or other equipment.

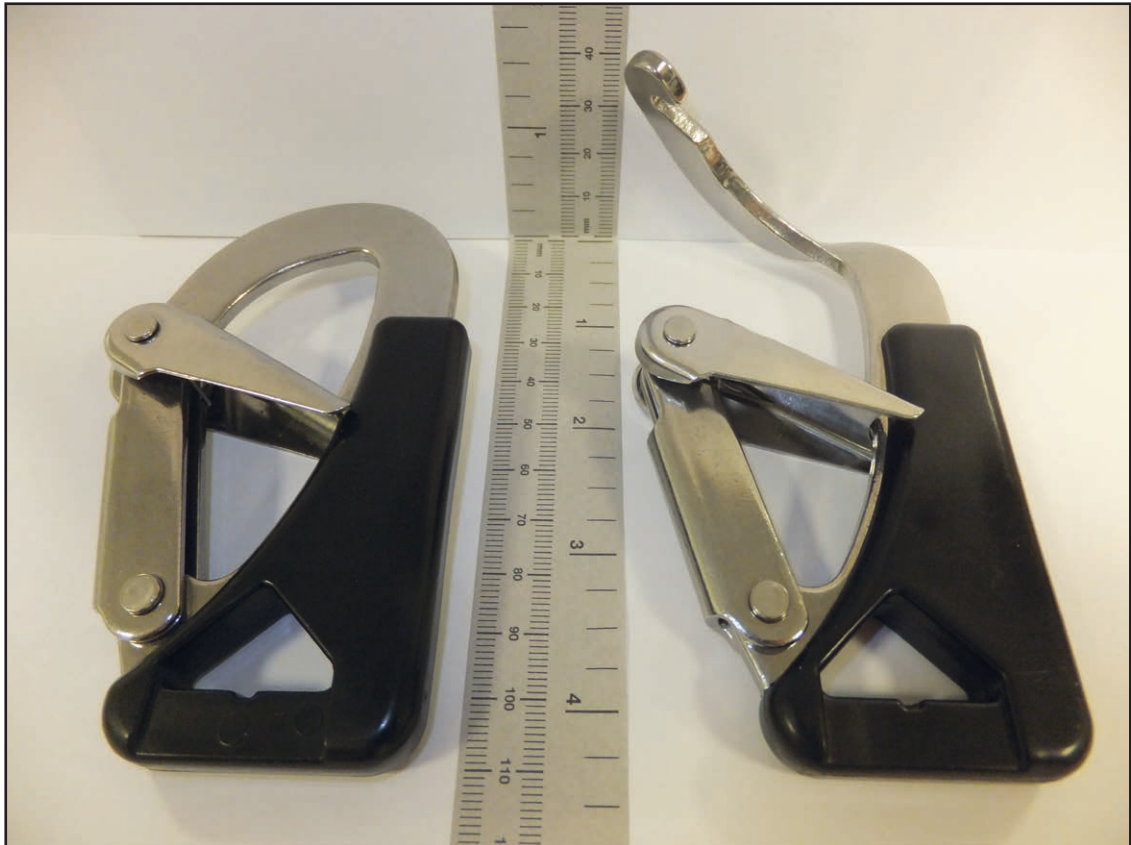
When loaded longitudinally, the tether can withstand a load of over 1 tonne. However, when loaded laterally a tether hook will deform at much less load. It is important that tether hooks remain clear of obstructions and are free to rotate to align the load longitudinally.

**Figure 2:** Example of a tether hook and a tether hook after lateral loading
